Failure Analysis on Leaked Tube of Furnace Boiler

Abstract: Furnace in oil companies is functioned to heat raw oil in process to produce various fuels, and outlet gas from the furnace is used for heating water in Furnace Boiler. Failure took place on tubes of Furnace Boiler. The purpose of this failure analysis is to find the root cause of failure. Methods conducted in this failure analysis are through examination and testing of fractography, metallography, chemical composition, hardness, and bulging measurement. Examination on the fracture surface by fractographic method revealed leakage due to excessive bulging and existence of excessive deposit/scale. Condition of bulging gave indication of long-term overheating due to excessive deposit/scale. Examination by metallographic method revealed that microstructure of ferrite and pearlite having grain growth due to exposed by local heating. However, result of chemical composition examination and hardness test showed that material of the furnace tubes were in accordance with ASTM A-192. Bulging measurement gave indication of excessive bulging up to 15% for the leaked tube. Therefore, failure of leaked tube of Furnace Boiler was caused

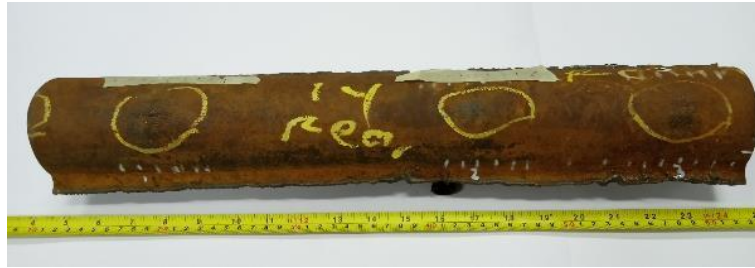
It is given a tube sample of furnace boiler (Figure 1). In oil companies, furnace is one of some sequence processes to produce fuel. In the furnace, tubes contained raw oil is heated by gas. Gas outlet from furnace is then used for heating boiler to heat water tubes. So that is why the construction is named of furnace boiler [1].

Figure 1. Tube sample of Furnace Boiler

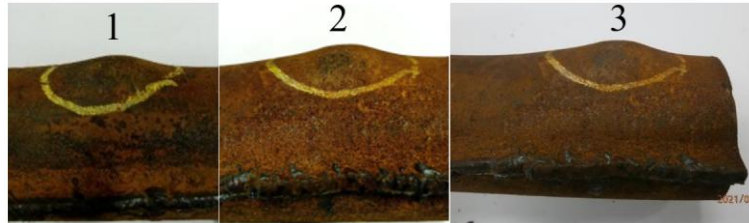
Figure 2. Bulging 1, 2 and 3 on tube of furnace boiler

Condition of bulging on the tube is shown in Figure 2. The purpose of this failure analysis is to find out the root cause of failure on furnace tube and to provide recommendations in order to prevent similar failure in the future.

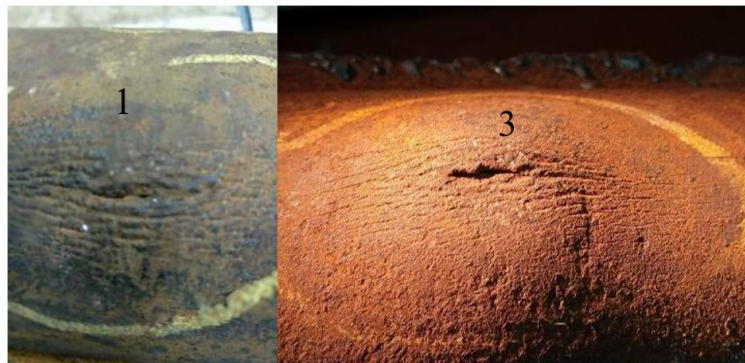
Figure 3. Leakage took place at bulging 1 and 3

Examination result of fractography on the fracture surface of tube shows longitudinal stretch lines on the bulging 1 and 3 as shown in Figure 3. On the top of bulging it can be seen stretch line that has leakage. As shown in Figure 4, it can be seen thick deposit on inner surface of tube at bulging side.

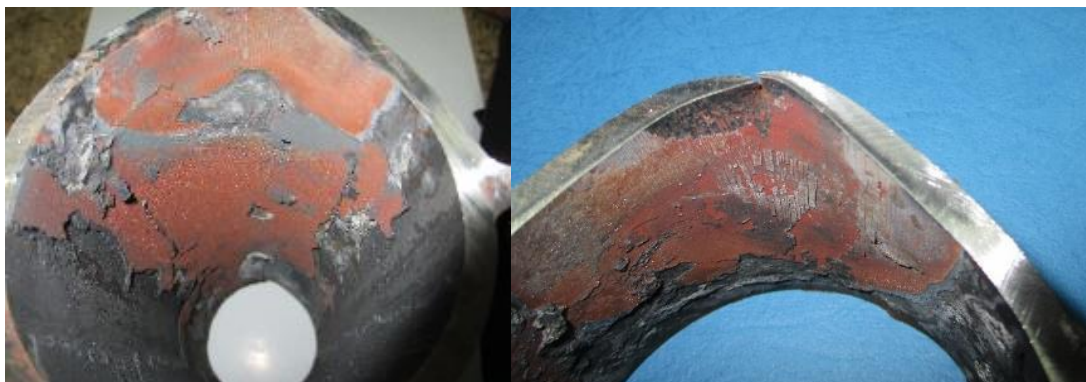
Figure 4. Thick deposit can be observed on inner surface of tube

As can be seen in the Figure 4 that the deposit can act as local stress riser due to local high temperature. Examination result of metallography shows that the microstructure of tube is ferrite and pearlite. But grain size on bulging position is greater than that of normal position as can be seen in Figure 5 and 6 [2].

Results of fractography and metallography examination show that the leakage took place at top of bulging, and inner side of bulging is inhabited by excessive deposit, also at lateral section of bulging shows grain growth. Combination of these findings gave a clue of long-term overheating [4], [5]. Formation of deposit should be related to flow pattern and operation system and water quality. Since deposit formed, heat received from gas could increase local heat because the heat is absorbed by the deposit, and not transferred to water. Long-term overheating induced high local stress and slowly created bulging. When the bulging is not detected early, it will continue to cause leakage [6]–[12].

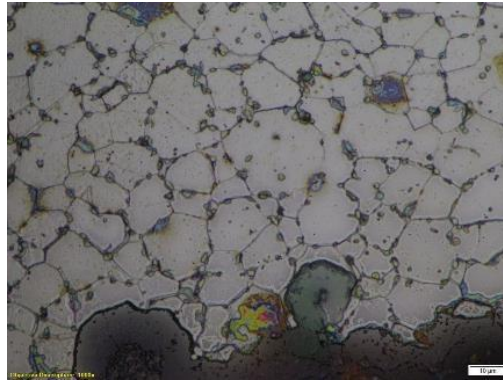
Figure 5. Grain growth microstructure on building 1, 500x

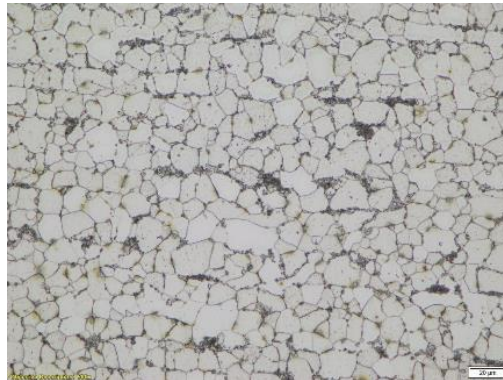
Figure 6. Normal size microstructure, 500x
